St. George Hotel Complex 16 Alarm Fire

Brooklyn, New York

UNITED STATES FIRE ADMINISTRATION FIRE INVESTIGATIONS PROGRAM

August 26, 1995

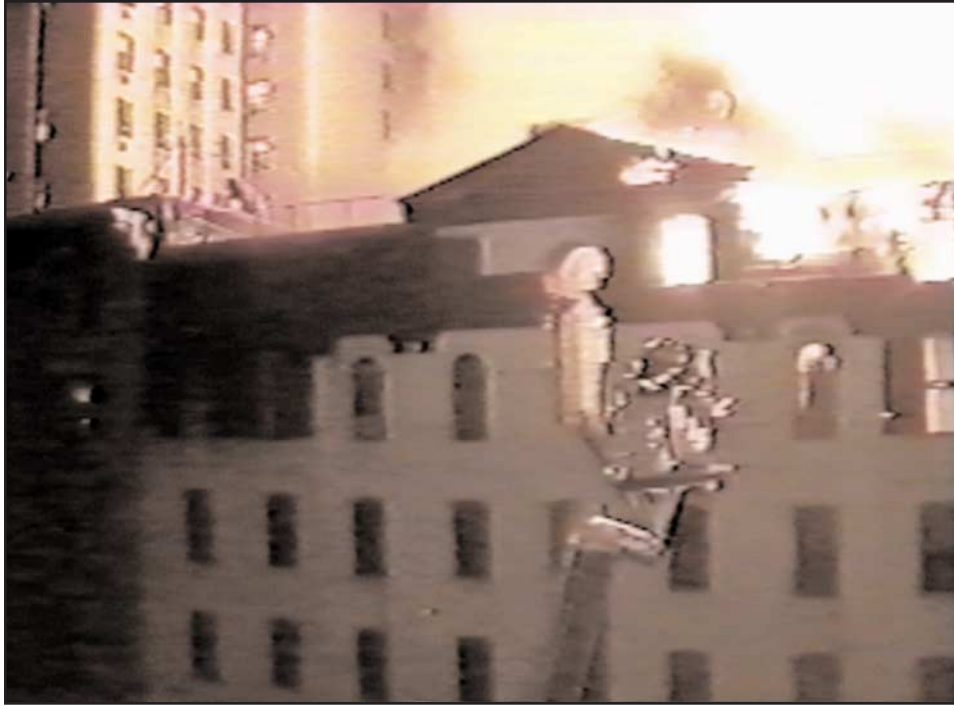
1. Early conditions on the Clark Street (front) side of the Clark building with Truck 119 in position to operate its elevated master stream.

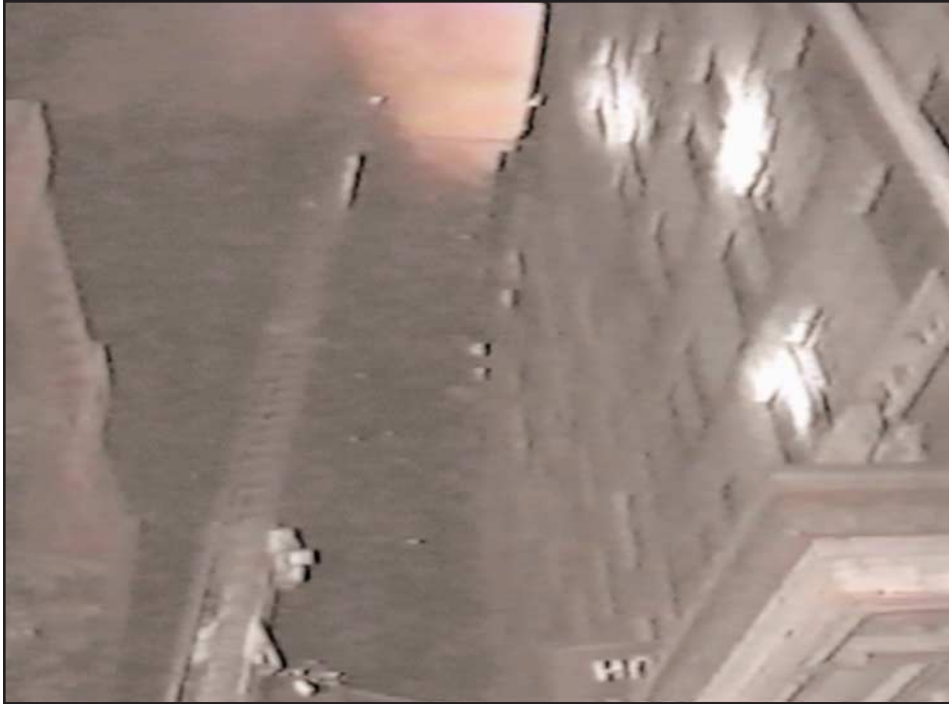
3. Conditions from the street.

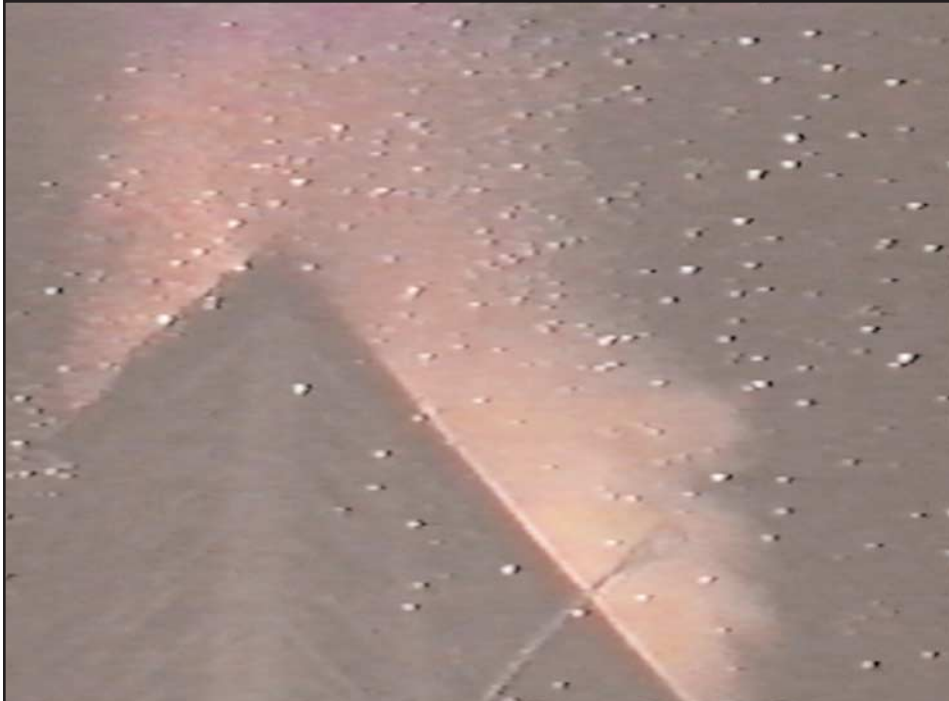
4. Illustrations of the fire brand conditions over the tops of the buildings.

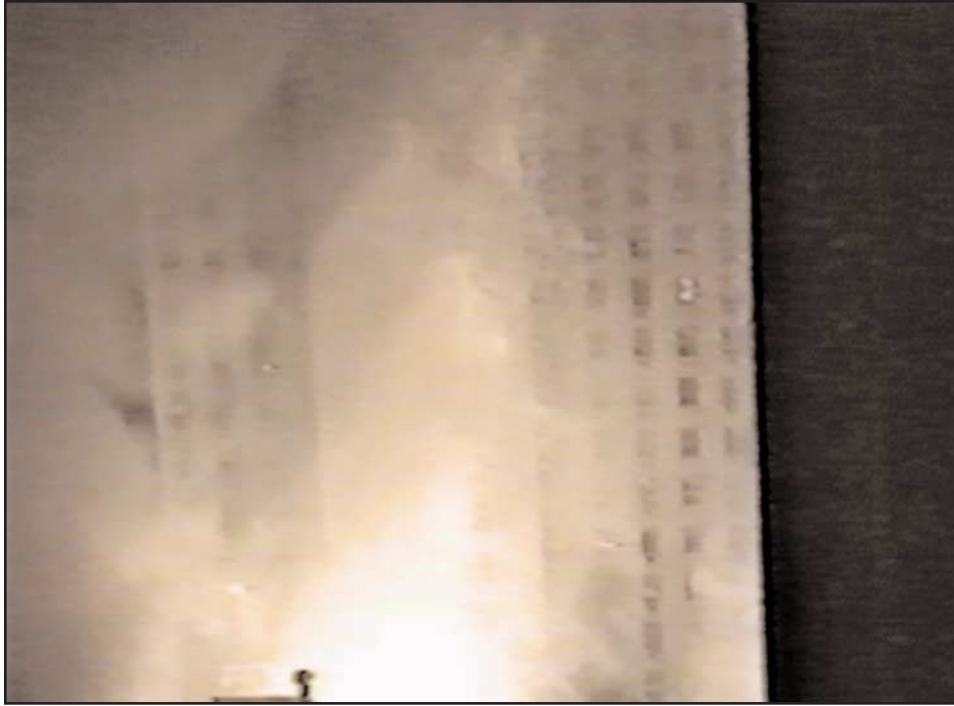
5. The fire, brand, and energy plume from the now totally involved and collapsed Clark Building silhouetted against the rest of the 31 story Tower building.

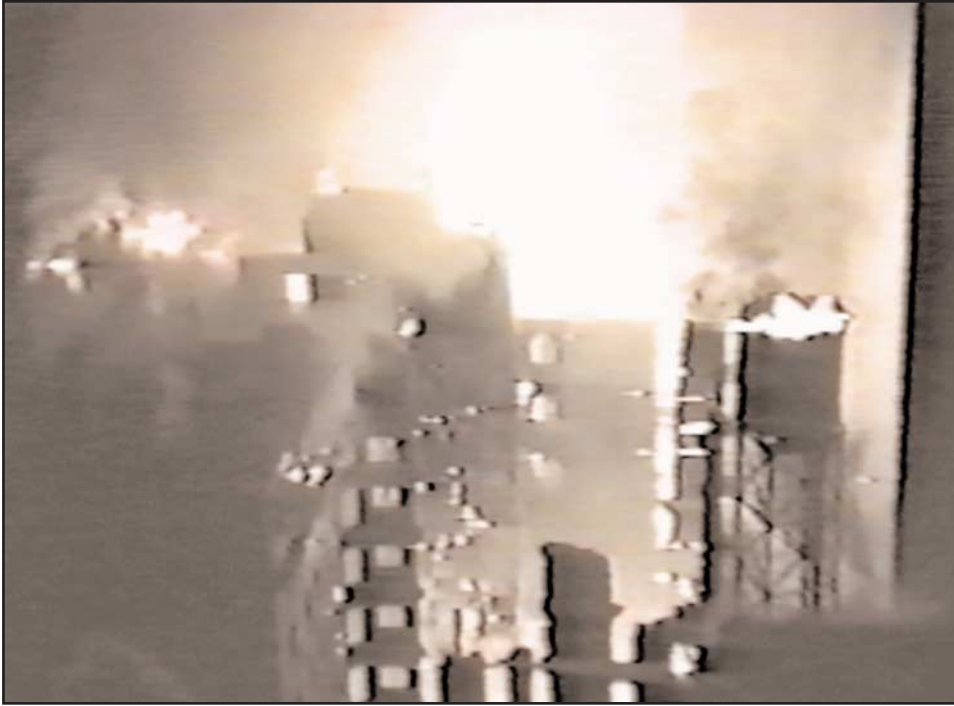
6. Fire conditions at the center of the block behind the Clark Building. The Tower building is in the background.

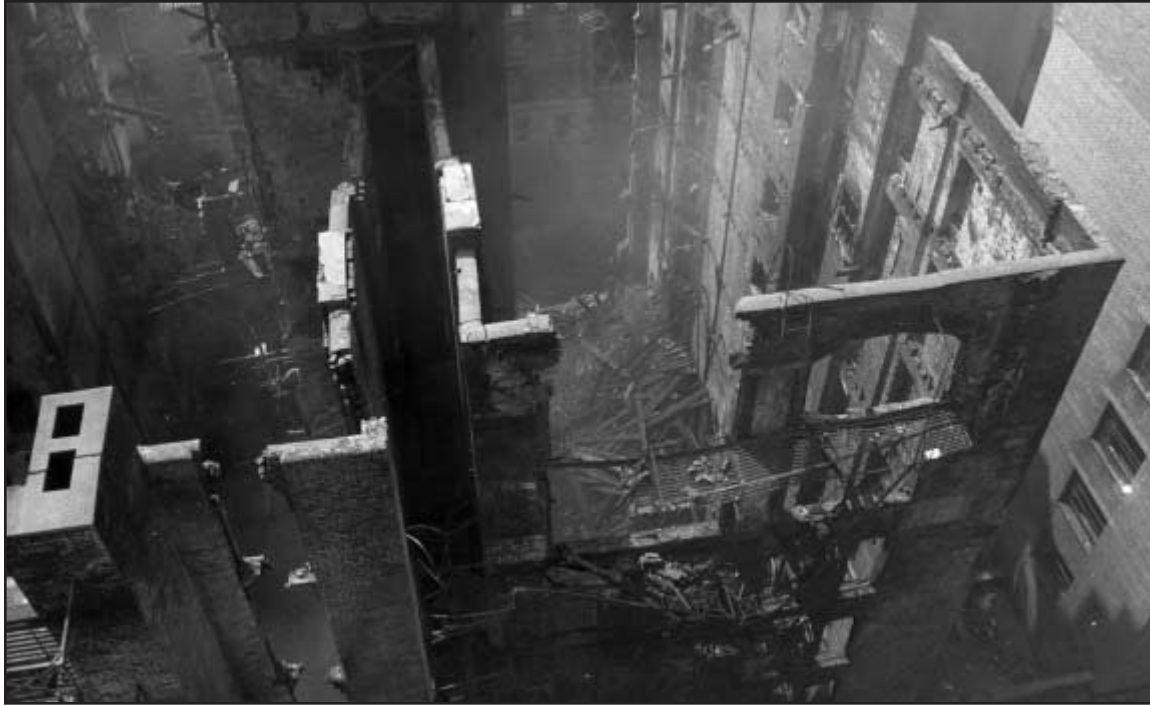
9. The Clark building during demolition as viewed from the rear to the front.

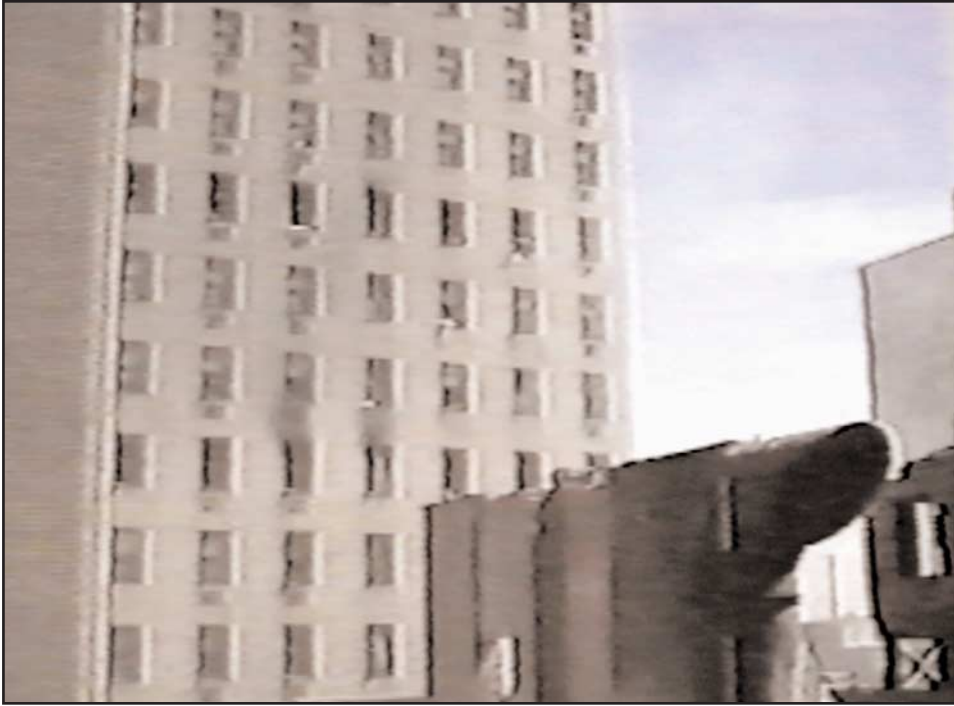
10. Damage to exposures across Clark Street from the fire building.
