St. George Hotel Complex 16 Alarm Fire

Brooklyn, New York

UNITED STATES FIRE ADMINISTRATION FIRE INVESTIGATIONS PROGRAM

August 26, 1995

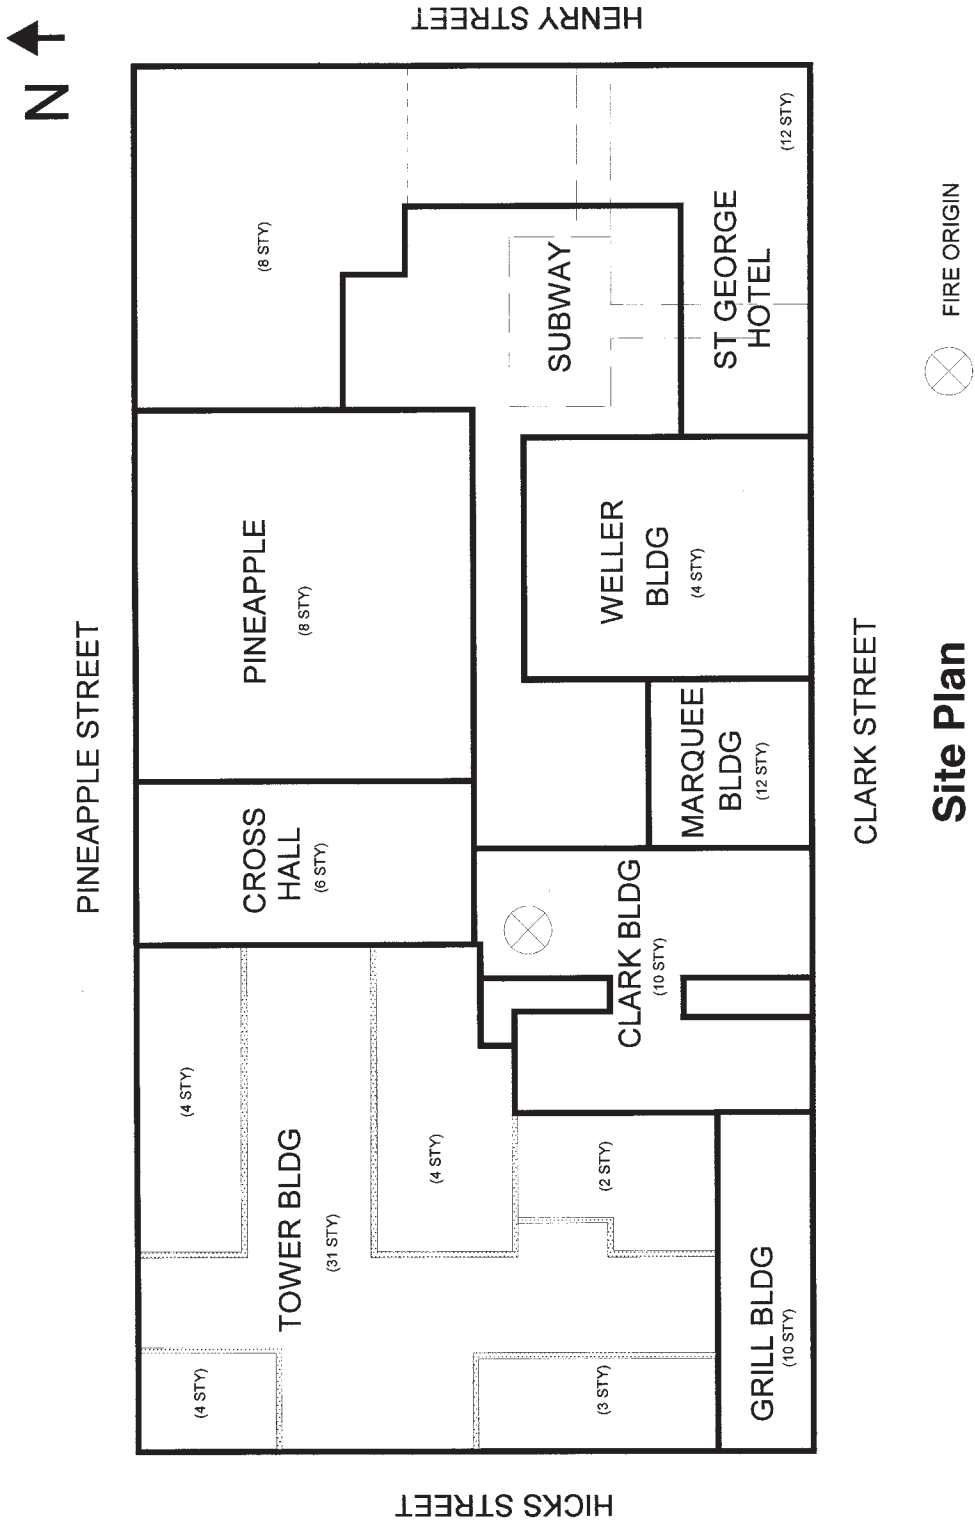
The St. George Hotel was the grandest of New York City's hotels when it opened in 1926. Located in the Brooklyn Heights area of the city, it had a total of 2,632 guestrooms in a complex of eight buildings that occupied an entire city block. (Figure 1). Some of the original buildings dated back to 1885. All the buildings were interconnected at the basement level, and there were numerous connections on various floor levels among the different buildings.

The complex was bordered by Pineapple Street to the north, Clark Street to the south, Hicks Street to the east and Henry Street on the west. Many streets in the Brooklyn Heights area are only 40 feet wide. Parking on the streets in front of the fire building further congested the area. Figure 1 shows the block and the relationships of the buildings to each other.

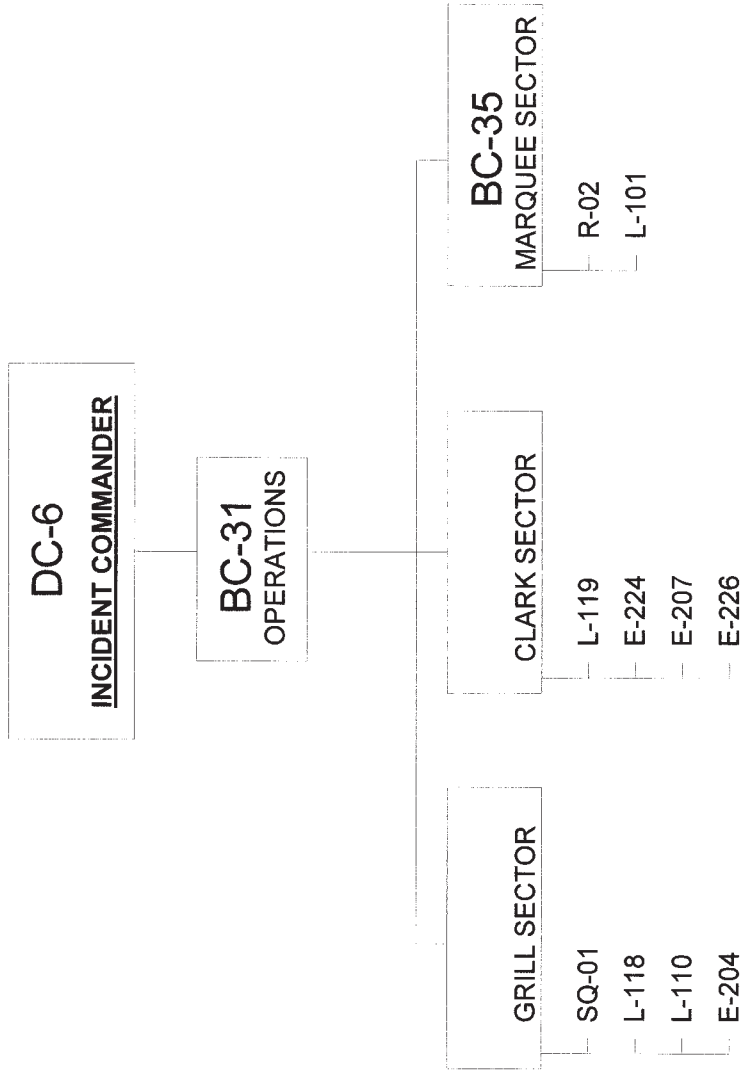
Figure 2

The two first alarm truck companies performed a primary search of the fire building. After making their way up the stairs to the eighth floor, the engine companies connected 2-1/2 inch hand lines to the standpipe and the order was given to charge the system. However, the standpipe had apparently been scavenged and sections of the pipe were missing. The 2-1/2 inch hand lines were then lowered out the windows, hooked up to an engine in front of the building and charged. At this point the command post was in the street in front of the building. BC-31 was Incident Commander. (Figure 2).

INCIDENT COMMAND STRUCTURE AT ABOUT 3:50 AM

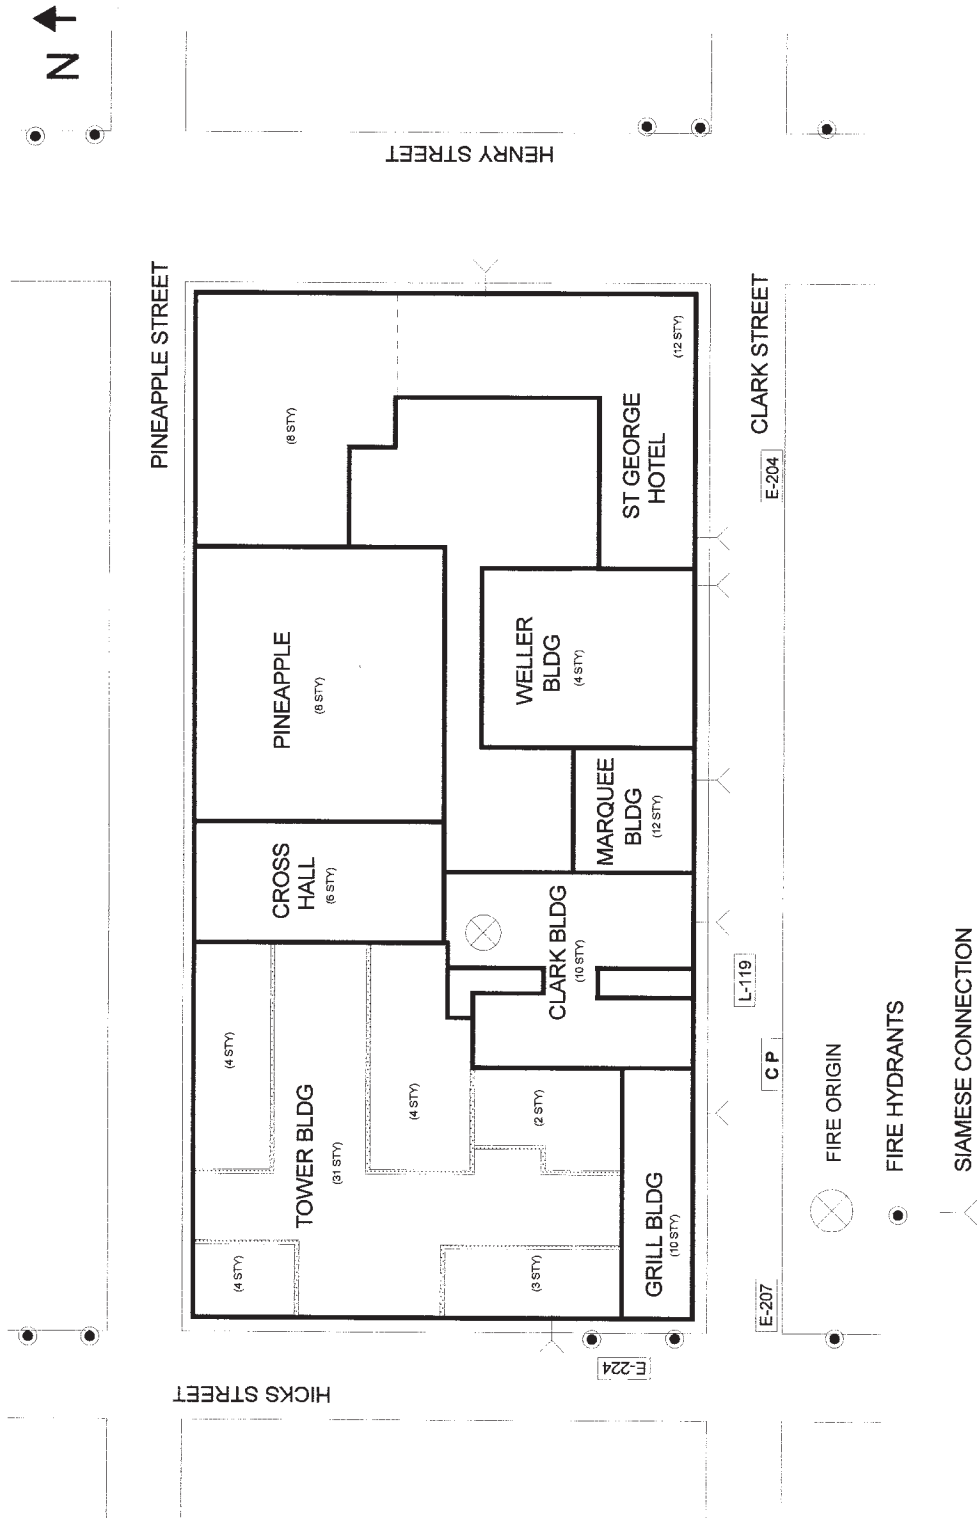
Figure 3

At 4:06 the first arriving Deputy Chief, DC-6, ordered a third alarm and assumed incident command. (Figures 3 and 4) As the fire was beginning to spread to exposure 4, the Marquee Building. The third alarm brought in four engines, 2 trucks, the Air Mask Maintenance Unit and a Medical Command Unit.

INCIDENT COMMAND STRUCTURE AT ABOUT 4:10 AM

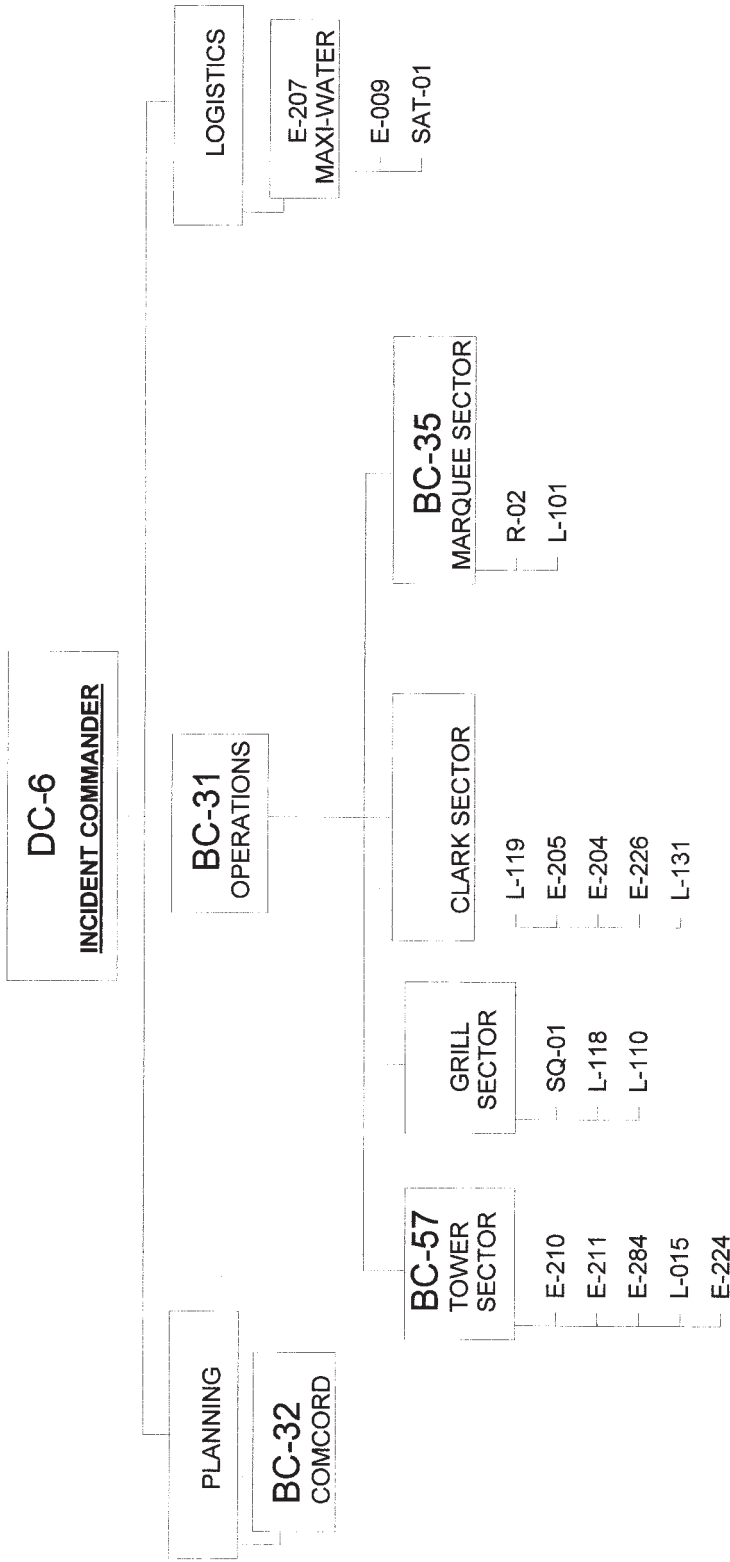
Figure 4

PLACEMENT OF "ALL HANDS" COMPANIES AT ABOUT 4:10 AM

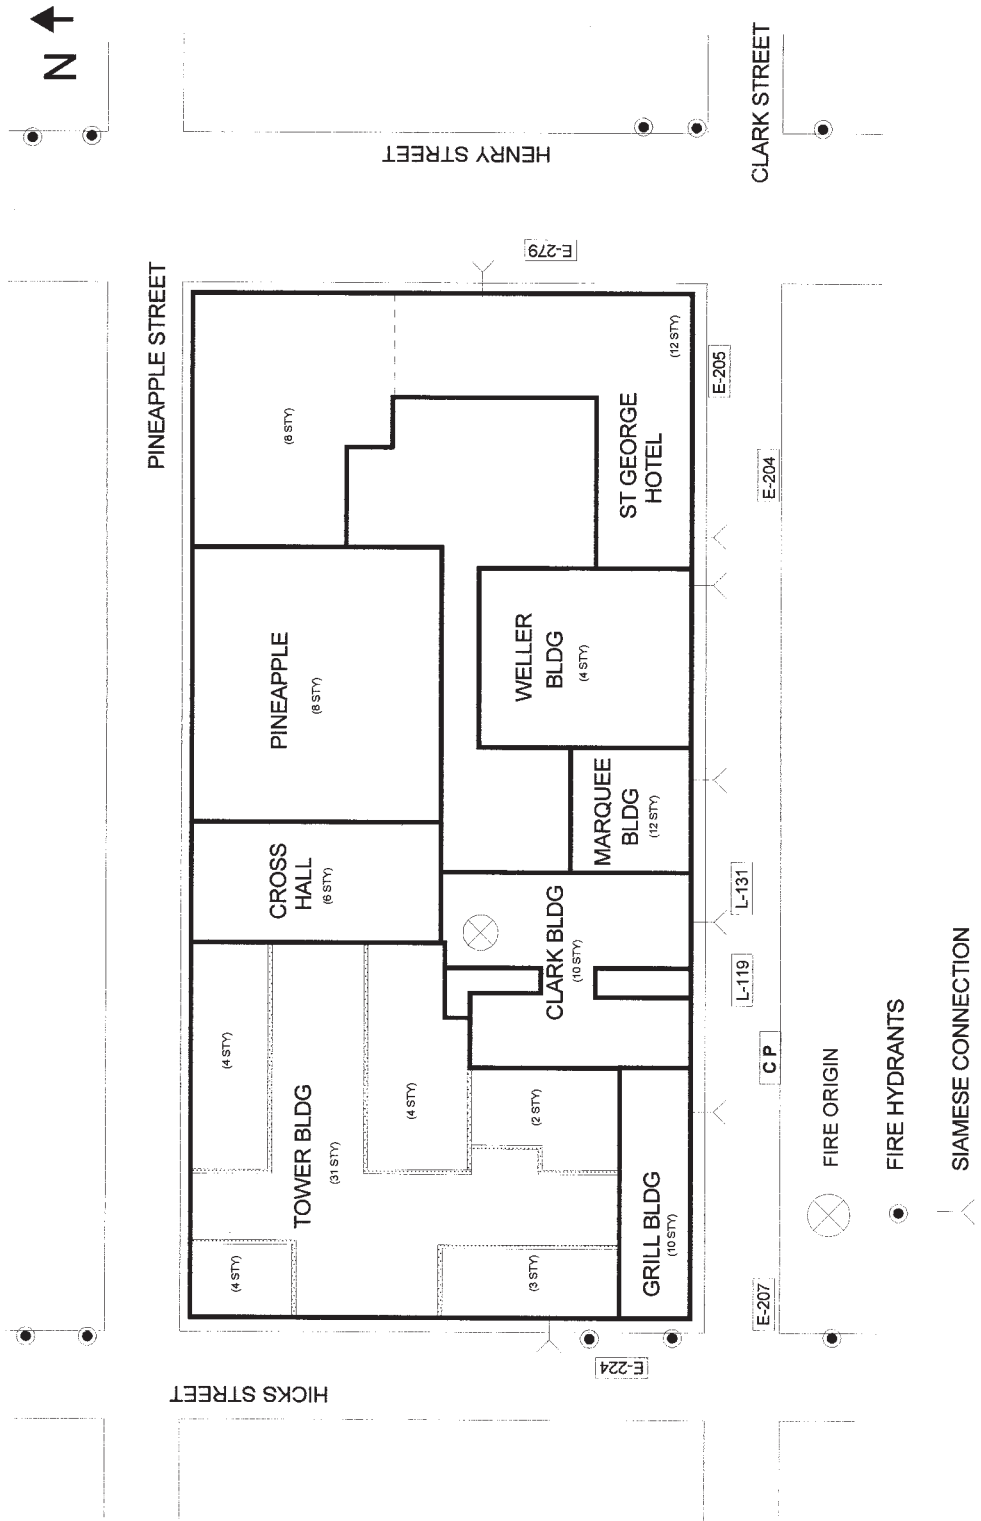
Figure 5

The Citywide Tour Commander FC 1 requested a fourth alarm at 4:11 a.m. while he was still enroute. From the Brooklyn Bridge he had an excellent vantage point to size up the volume of fire and the obvious exposure challenges. By this time the interior portions of the upper floors of the Clark Building were beginning to collapse, adding to the storm of fire brands. (Figures 5 and 6)

INCIDENT COMMAND STRUCTURE AT ABOUT 4:20 AM

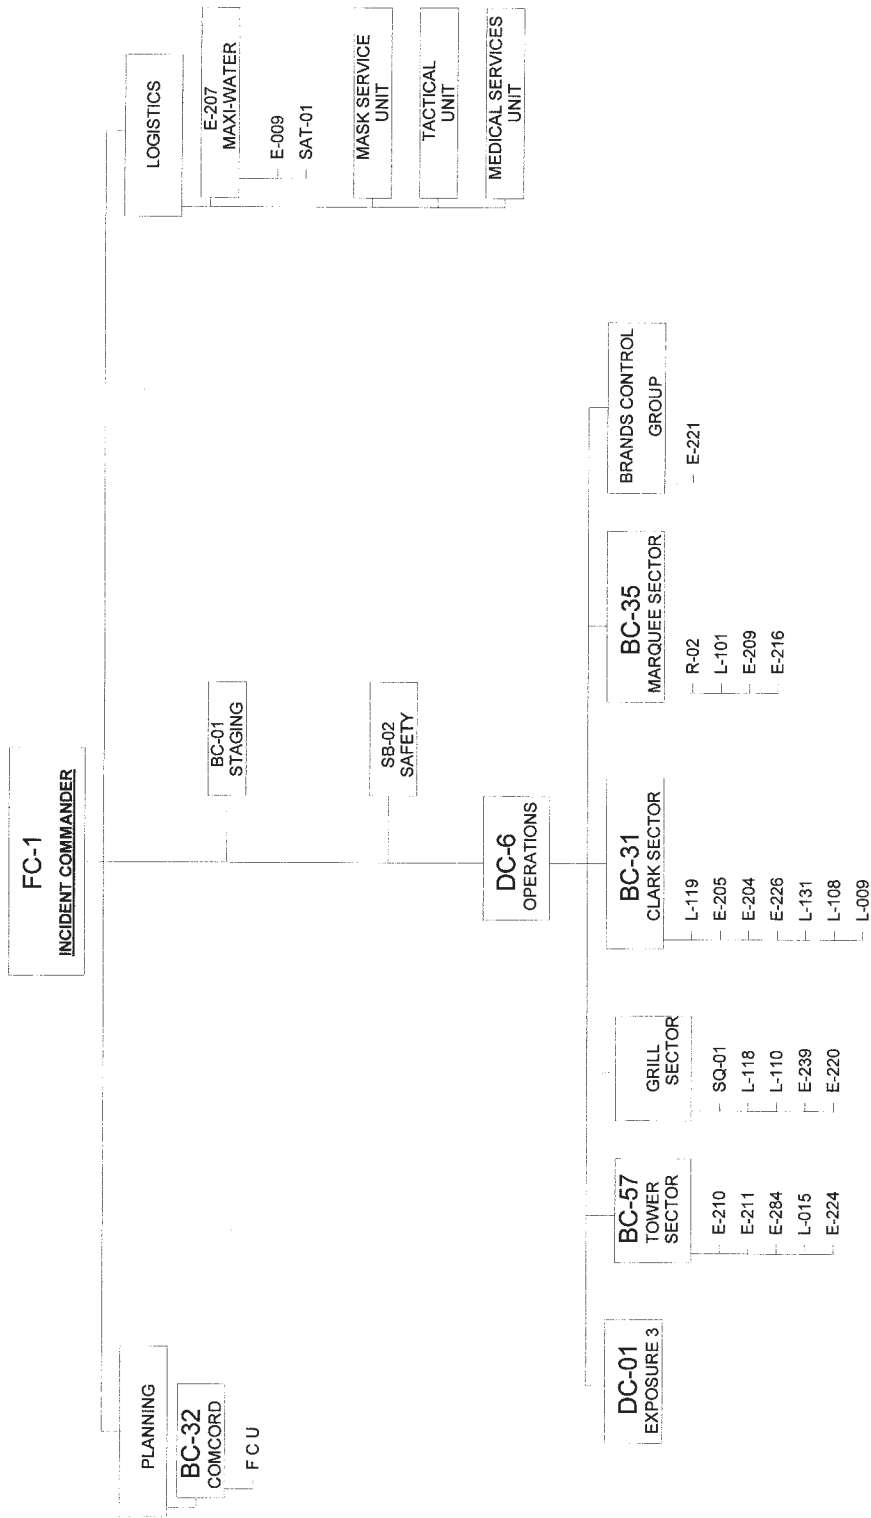
Figure 6

PLACEMENT OF SECOND ALARM COMPANIES AT ABOUT 4:20 AM

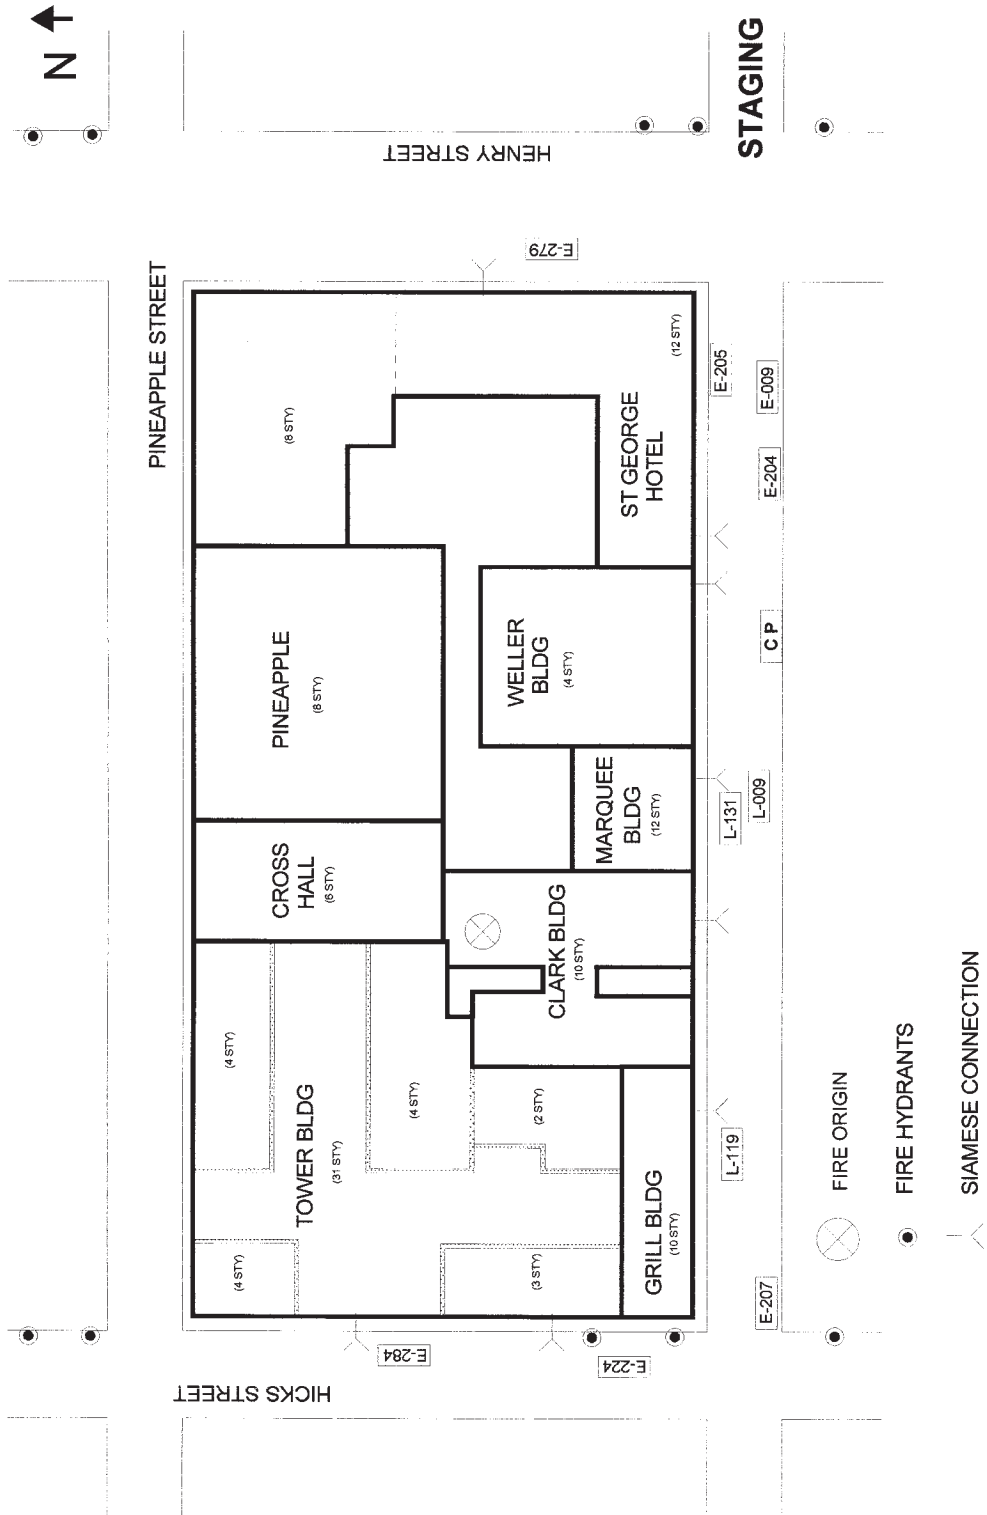
Figure 7

When FC-1 arrived on the scene at 4:18 a.m., he immediately called for a fifth alarm. The interior of the original fire building was well involved and the fire had spread to the upper floors of Exposure 4. A collapse zone was quickly established in front of the Clark and Marquee Buildings. The two tower ladders that had been set up in front of the buildings and the command post were repositioned out of the collapse zone. Battalion Chiefs were assigned to secure the collapse zone. (Figures 7 and 8)

INCIDENT COMMAND STRUCTURE AT ABOUT 4:35 AM

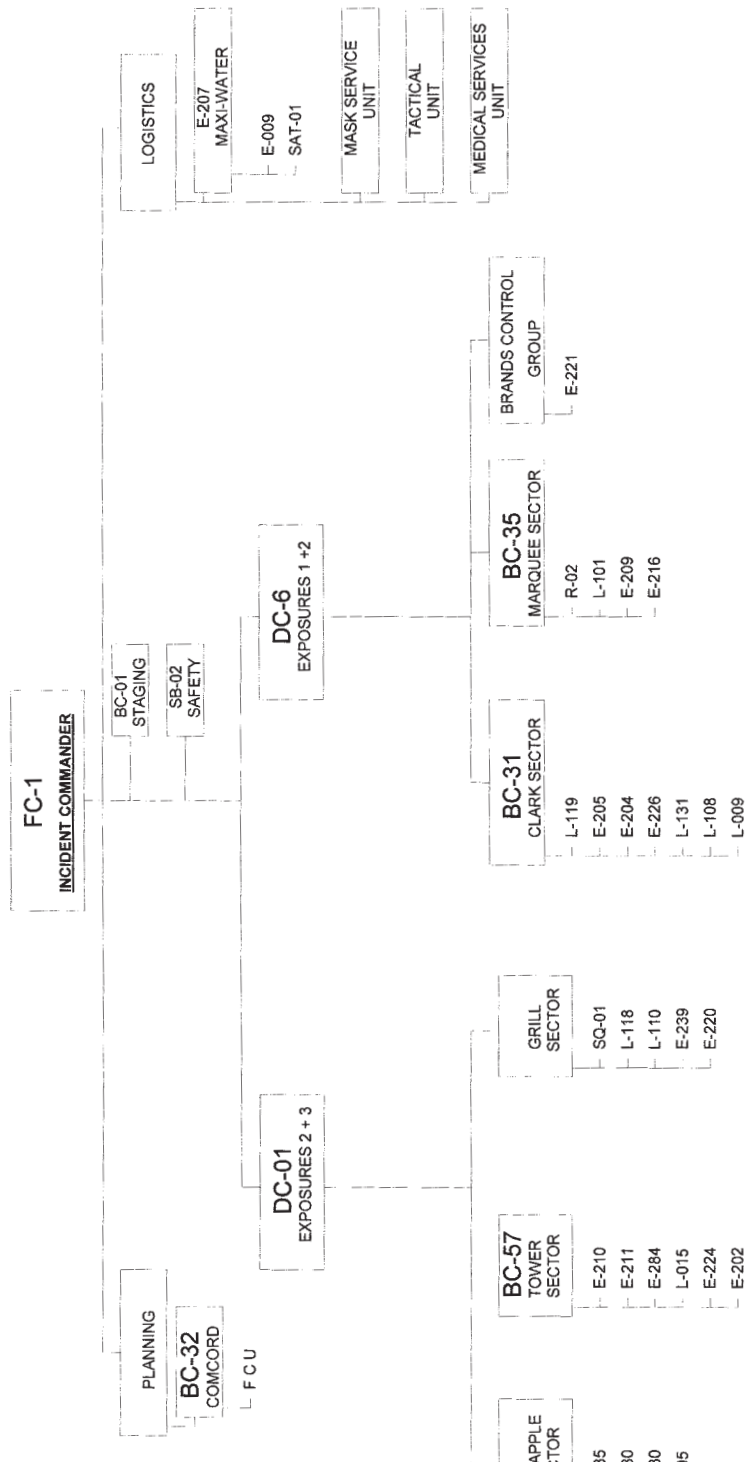
Figure 8

PLACEMENT OF THIRD ALARM COMPANIES AT ABOUT 4:35 AM

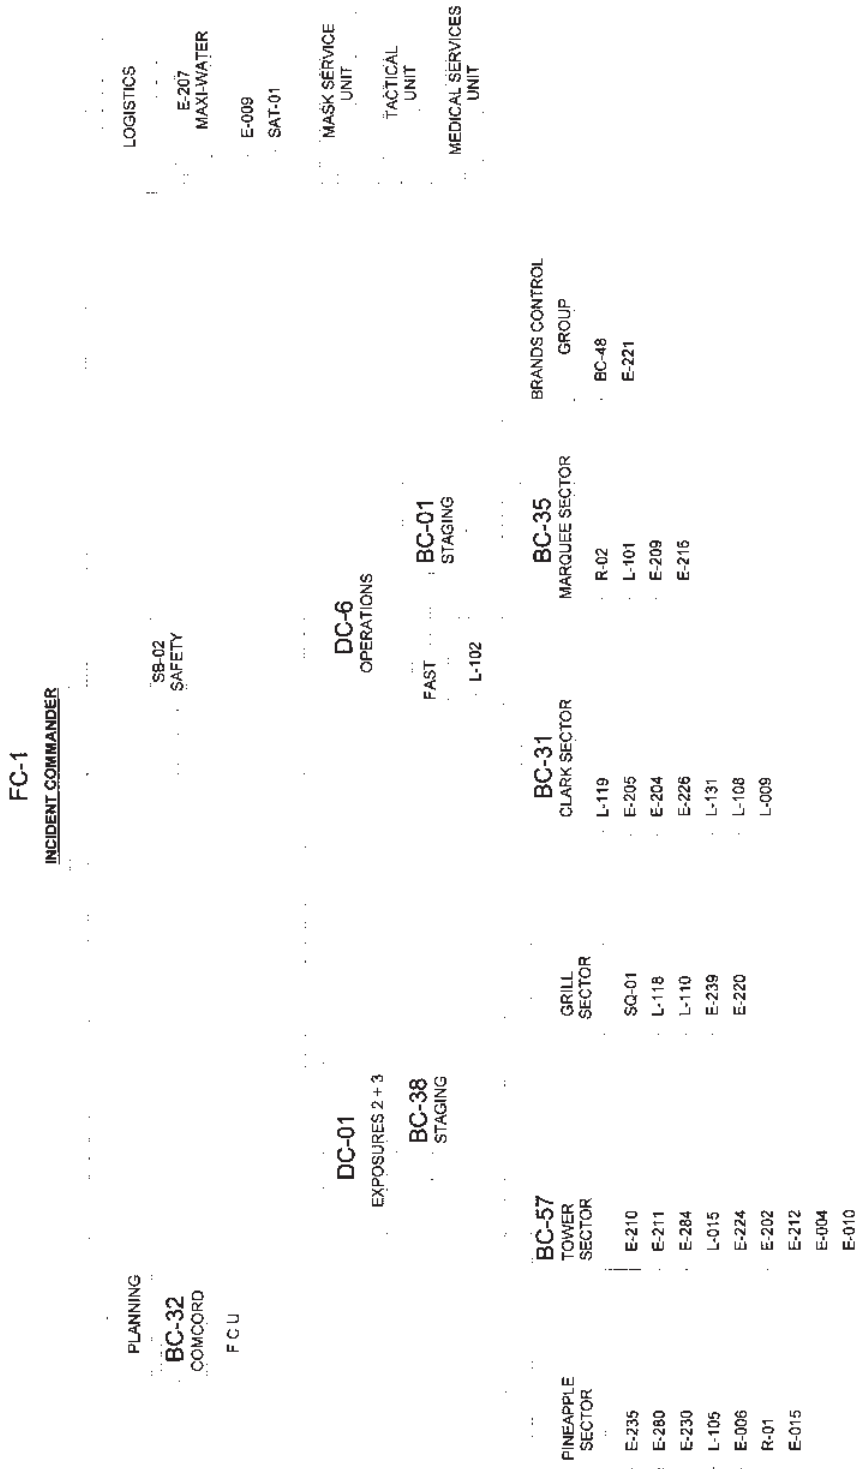
Figure 9

When the Incident Commander received this information he informed DC-1 of the building configuration and directed him to take charge of both Exposures 2 and 3 (Figure 9). The fireground was now divided into the Clark Street Branch, which included Exposures 1 and 2 and the fire building, and the Pineapple Street Branch, which included Exposures 2 and 3. Two Deputy Chiefs were assigned to direct operations in the two branches, DC-6 on the Clark side and DC-1 on the Pineapple side. The Incident Commander directed DC-1 to initiate a separate incident and to communicate directly with Brooklyn Communications to request resources.

INCIDENT COMMAND STRUCTURE AT ABOUT 4:45 AM

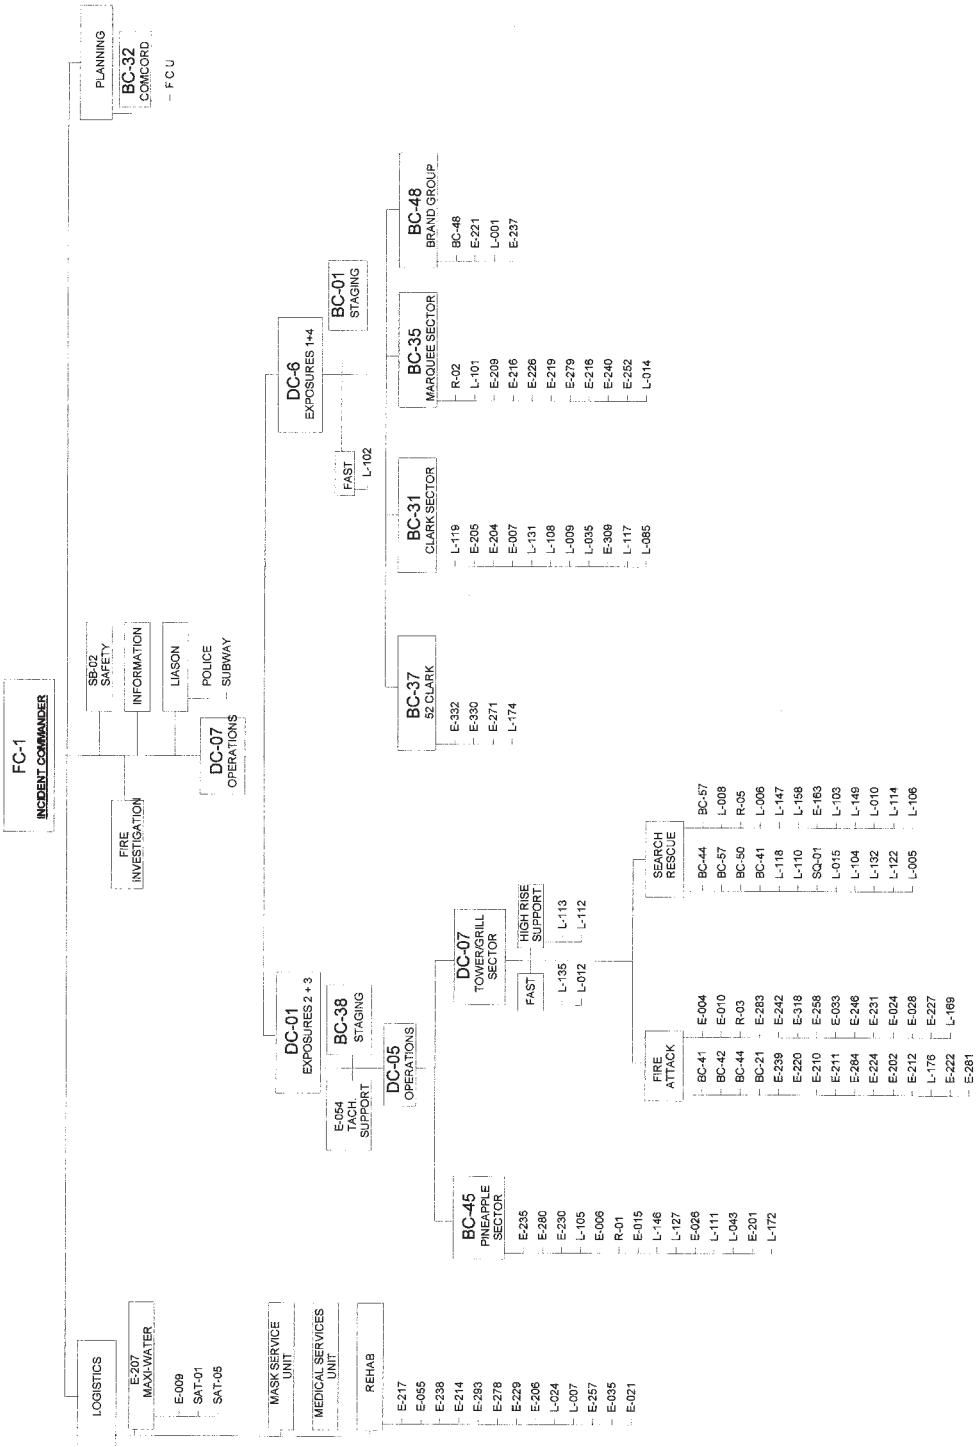
Figure 10

A secondary Command Post was established at the corner of Hicks and Pineapple and a second alarm assignment was requested by DC-1 to report to the Pineapple Sector, which included the Pineapple and Crosshall Buildings. The equivalent of a third alarm was requested to assist the companies that were already operating in the Tower Building. (Figure 10)

INCIDENT COMMAND STRUCTURE AT ABOUT 4:55 AM
